SERVICE INFORMATION CRUISE CONTROL

MS901 Boxer Pedal track fault

Date: 18-07-2013

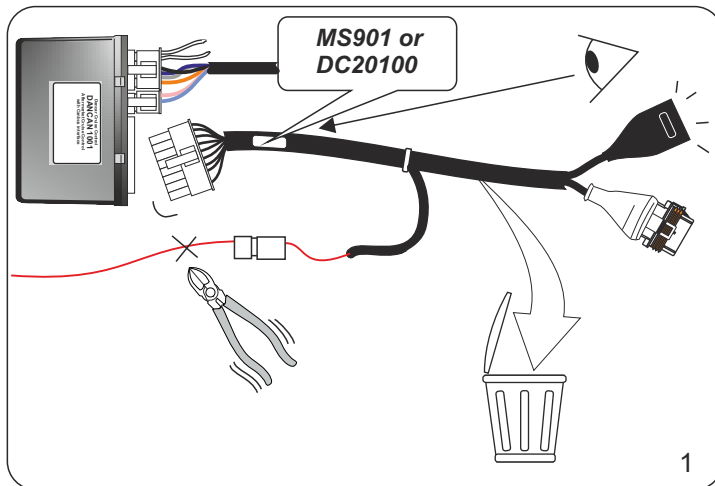
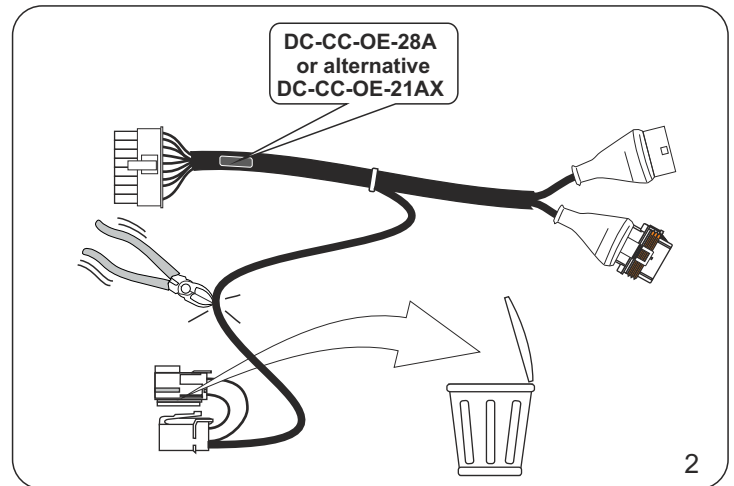
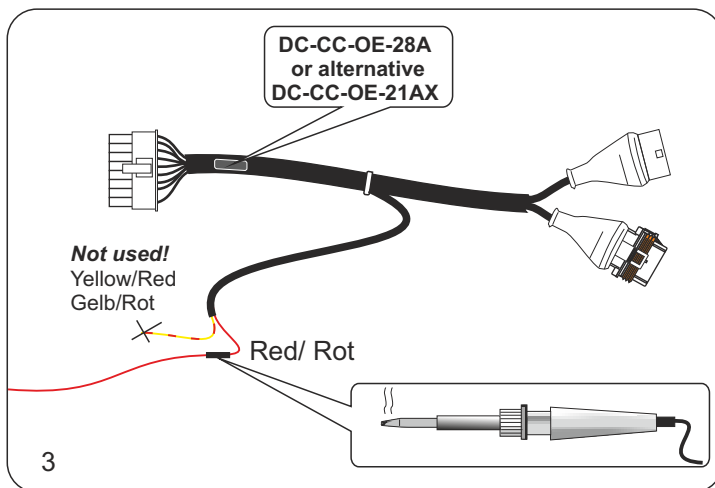
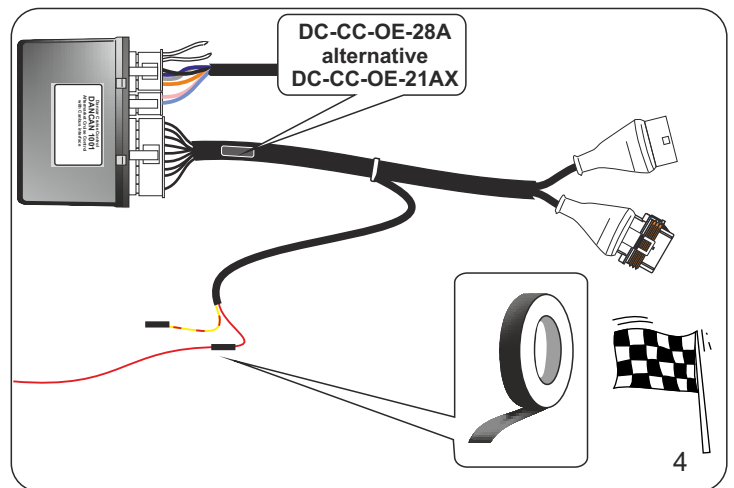
Bad connection between terminals and wire crimps inside the moulding connector (pedal interface) generate too high resistance.

Change out the existing main wire with new type part no. DC-CC-OE-28A or DC-CC-OE-21AX.
