SERVICE INFORMATION CRUISE CONTROL

E9600 99015 Pedal track fault

Date: 16-03-2012

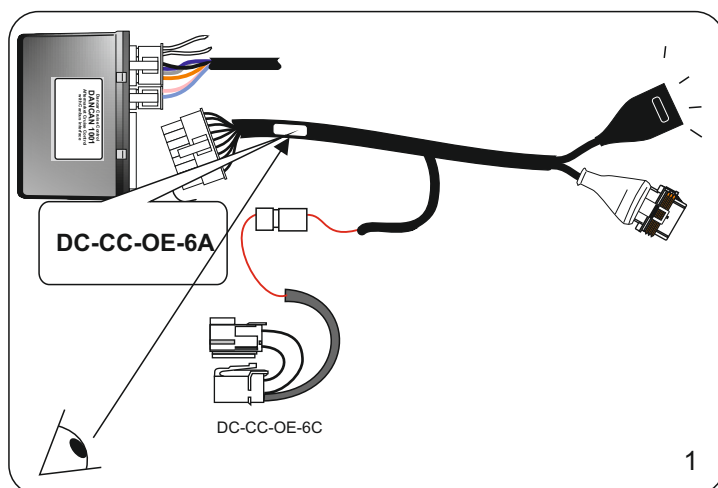
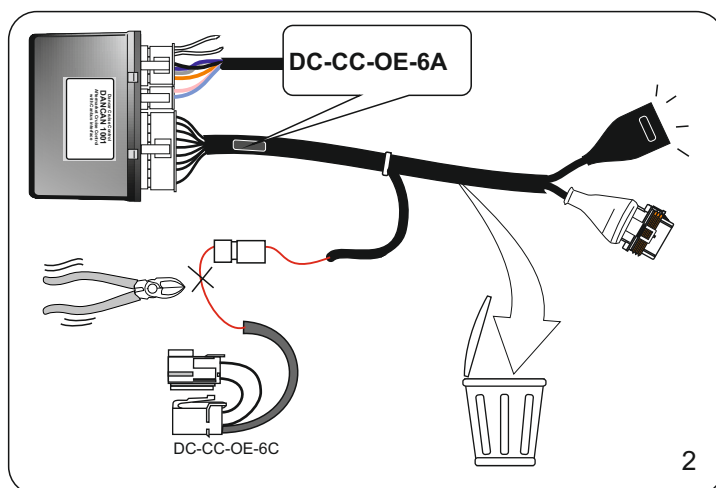
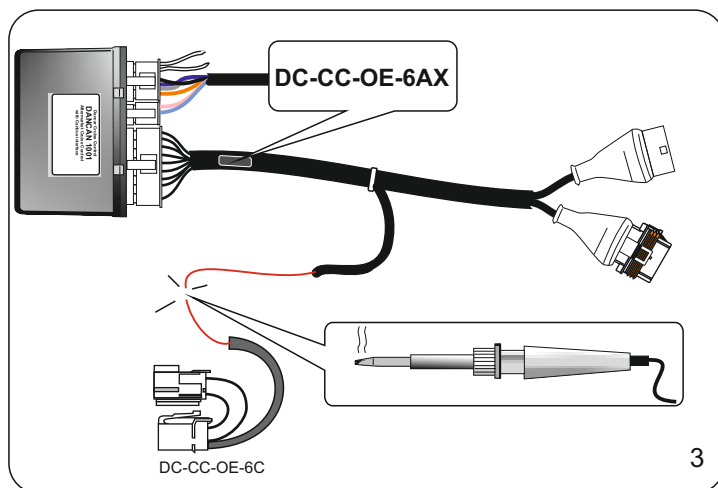
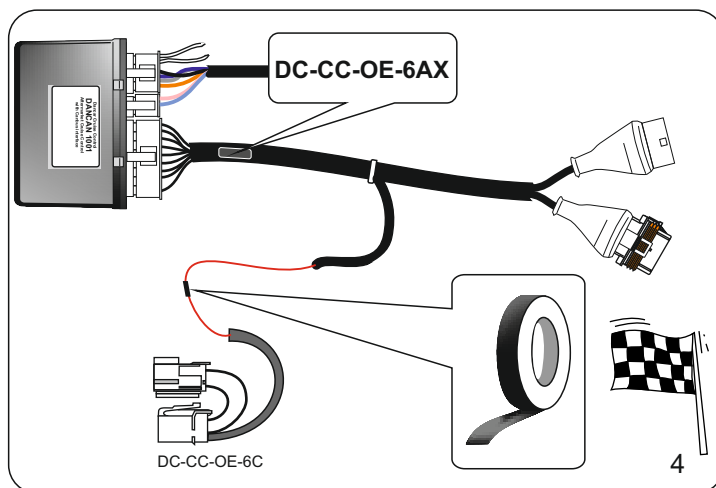
Bad connection between terminals and wire crimps inside the moulding connector (pedal interface) generate too high resistance.

Change out the existing main wire with new type part no. DC-CC-OE-6AX.
