SERVICE INFORMATION

Pedal track fault

Date: 17-01-2012

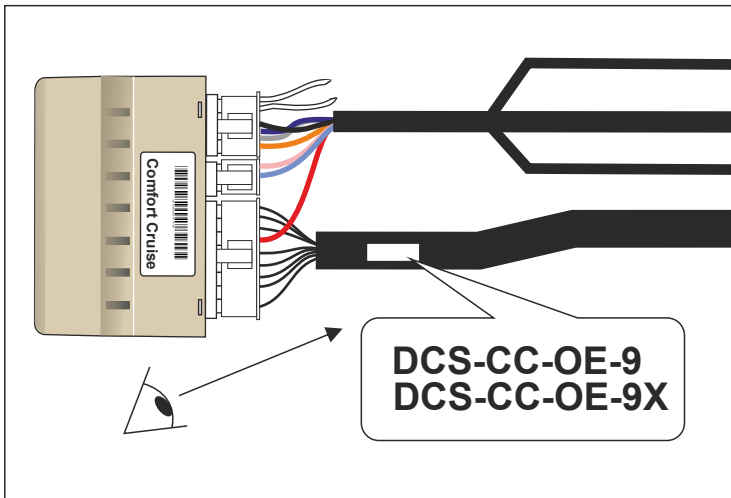
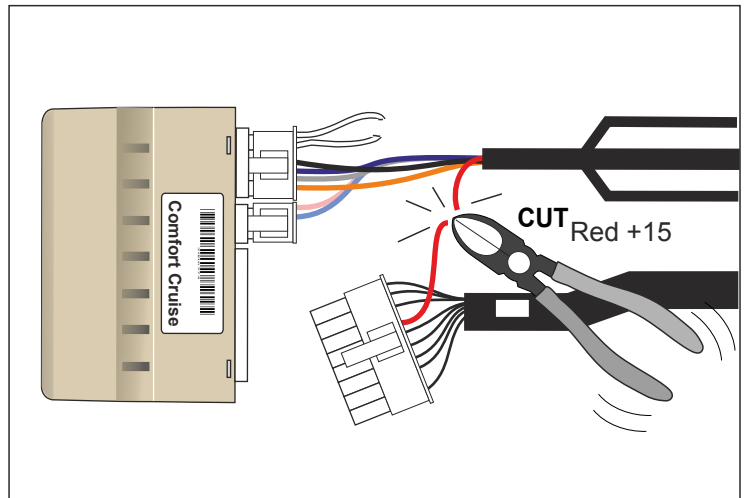
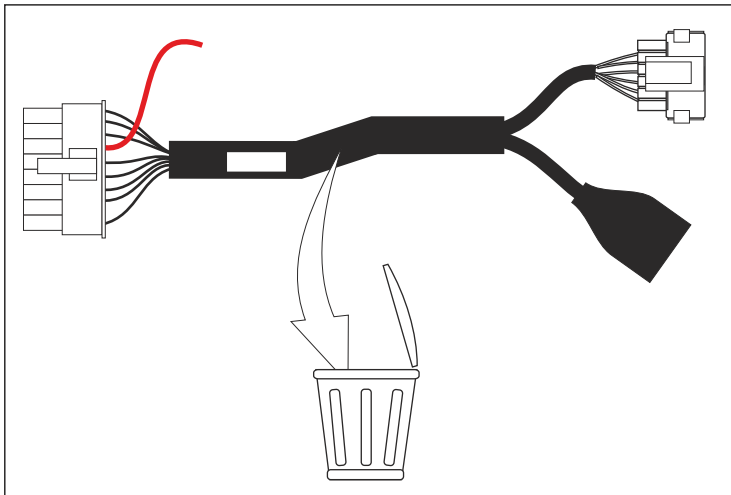
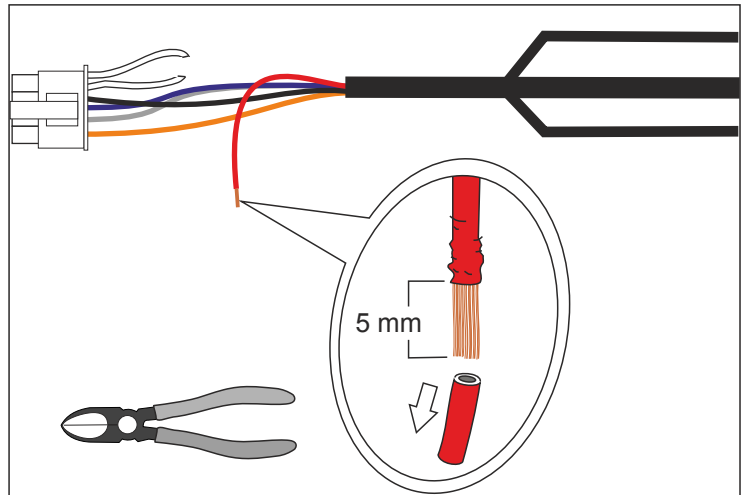
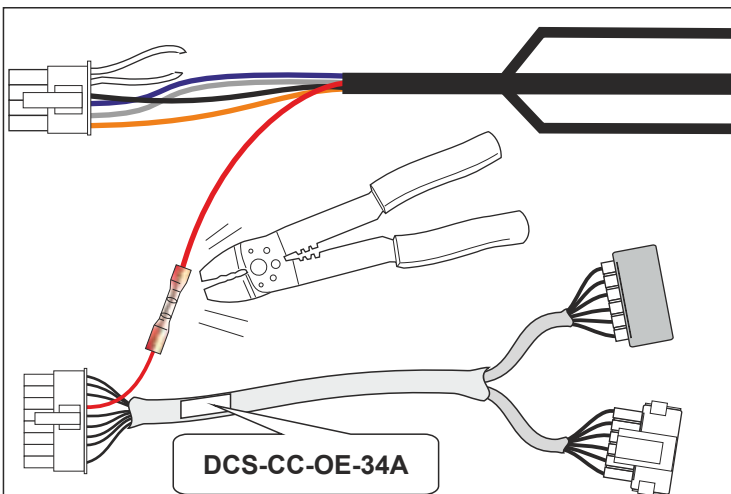
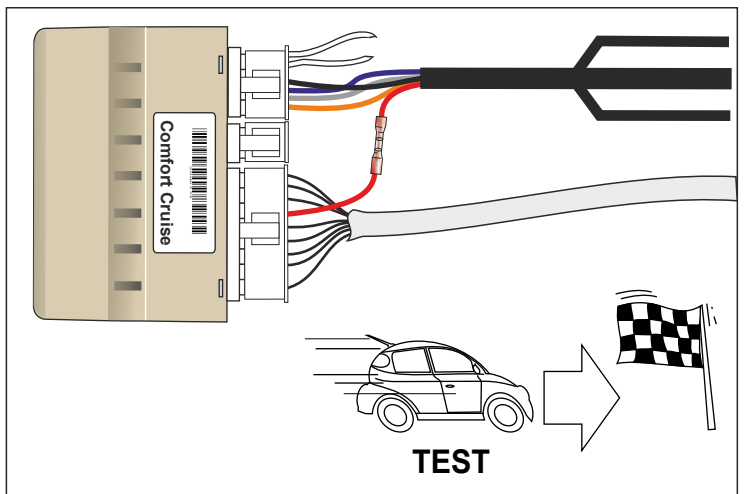
Bad connection between terminals and wire crimps inside the moulding connector (pedal interface) generate too high resistance.

Change out the existing main wire with new type part no. DCS-CC-OE-34A.
